Marmion Lake Mapping Project Update

December 19, 2007

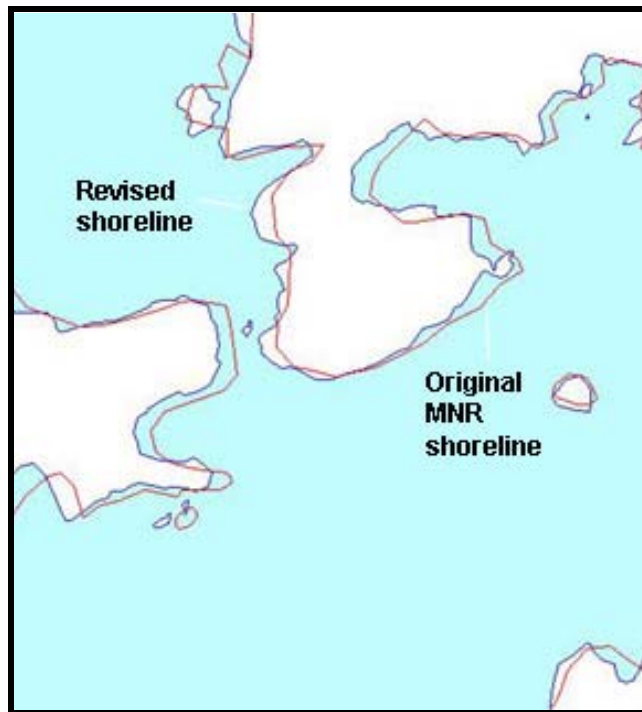
Figure 4: Detail of MNR vs. new lake boundary

shoreline has been completely re-digitized based upon the 1995/96 aerial photography. This involved digitizing some 26,000 vertices or points to form a new lake polygon. The new boundary encompasses and conforms to all the data collected in the lake survey. When the original MNR lake shapefile and the new lake shapefile are displayed overlapping on screen for the lake in its entirety, they appear virtually indistinguishable. This is to be expected, since they both represent the same lake and its' configuration. **Figure 3** displays the revised lake coverage with the original MNR coverage overlaid and shown as a red outline. However, when one zooms in on smaller sections of the lake, the differences become evident, although not large. **Figure 4** shows a detail of a section of the lake illustrating differences between the new lake coverage and the original MNR coverage shown as a red outline.

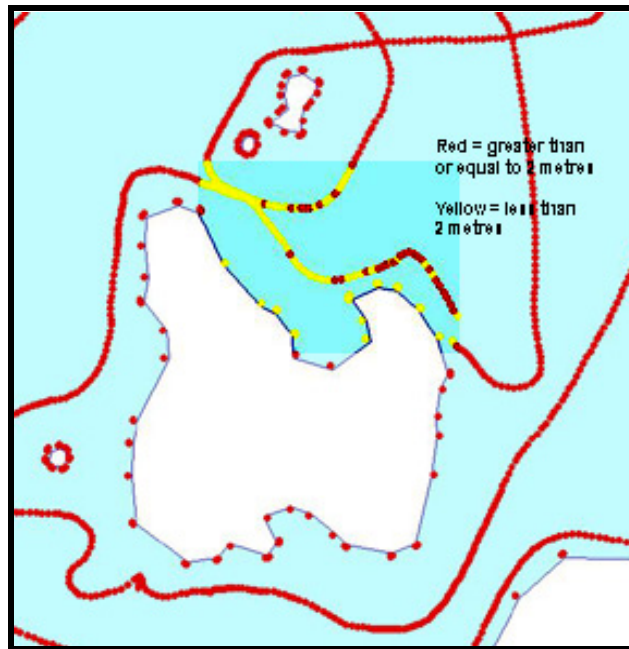
Figure 13: Distribution of depths recorded less than and greater than 2 metres in selected location

Figure 13 shows a small section of the lake with a small island and bay. The yellow highlighted depth records shown are all recorded as being above the 2 metre depth (for the area of the small bay only). **Figure 14** shows the 1965 photography for the same area. **Figure 15** shows the same area using the 1982 photography. Note that in neither photograph do any shallow areas show up in the small leeward bay of the island, such as those clearly evident and above 2 metres surrounding the tiny island off the northeastern point. **Figure 16** shows the TIN-generated contours for this area and **Figure 17** the corresponding grid-generated contours, Finally, **Figure 18** shows the adjusted 2 metre contour line in this location.
